**HOME INSPECTION  
REPORT**

123 Any Street  
City, State Zip Code

Inspection: 14-xxxx  
Date of Inspection:  
Engineer:

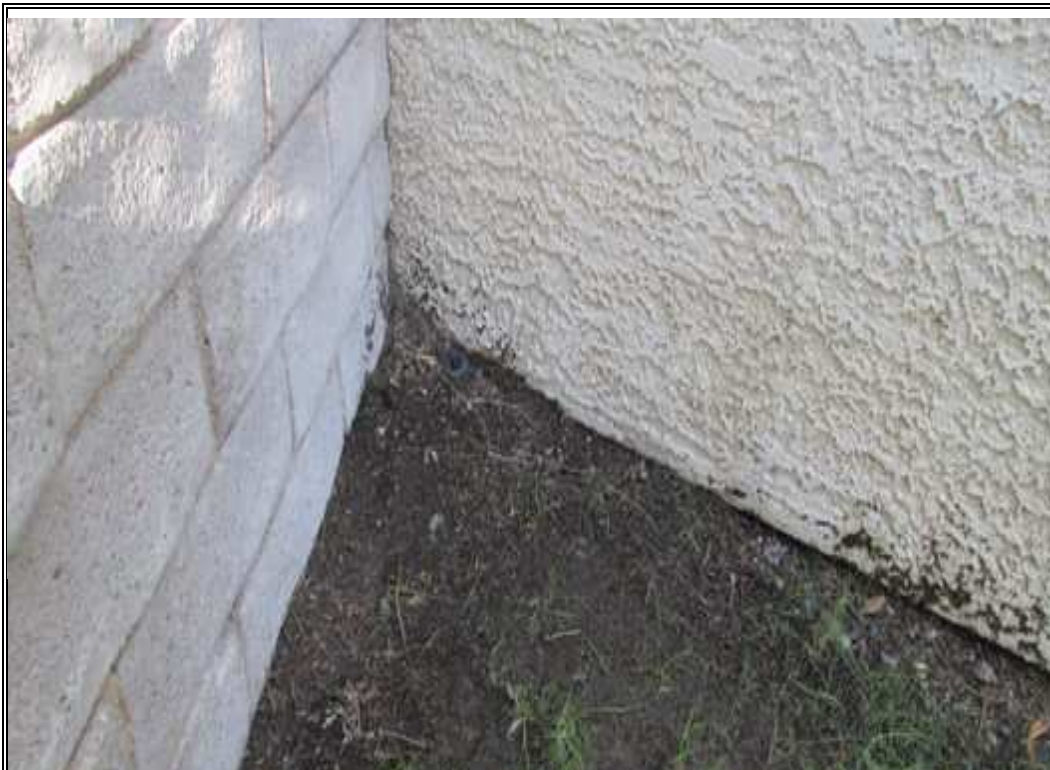
The soil is in contact with the stucco on the left side.

Regrading is needed on the left side of the house to lower the soil grade and eliminate soil/stucco contact. There should be at least 2 inches of exposed foundation between the bottom of the stucco and the soil.

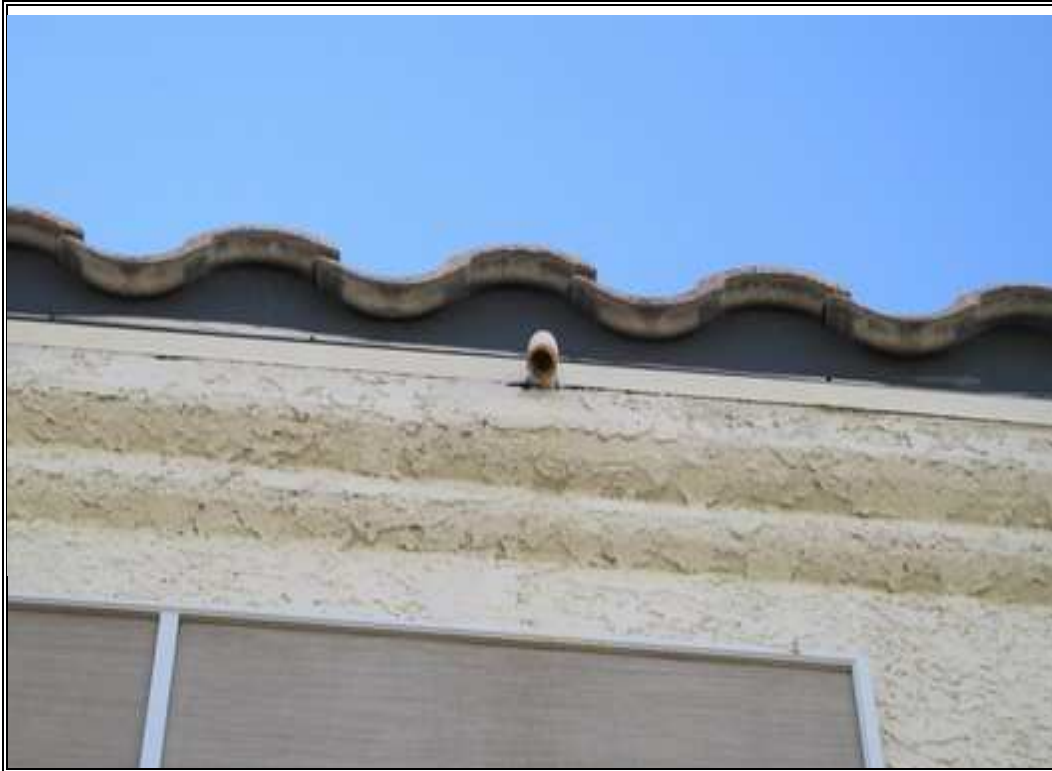
- There is evidence that the attic air handler primary condensate drain is plugged. This should be investigated further, and repaired as needed.
- The condensate drain is damaged at the garage air handler.

The primary condensate drain line in the attic is plugged.

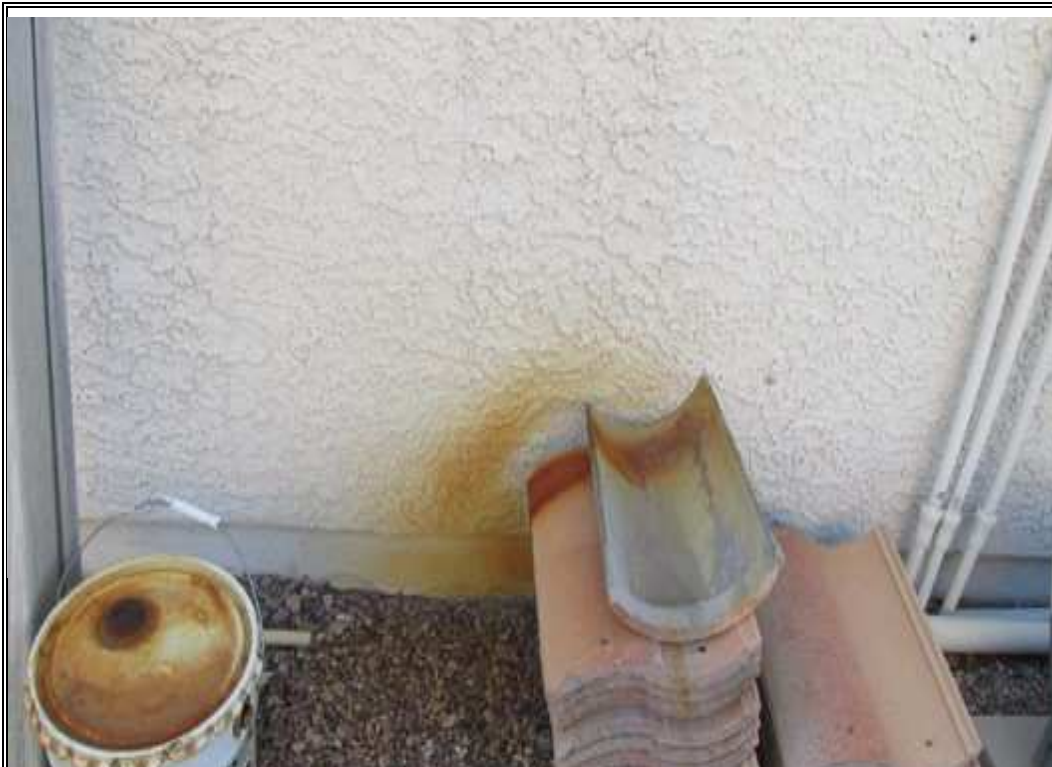
**Photo Number**  
**3**

The primary condensate drain line in the attic is plugged.

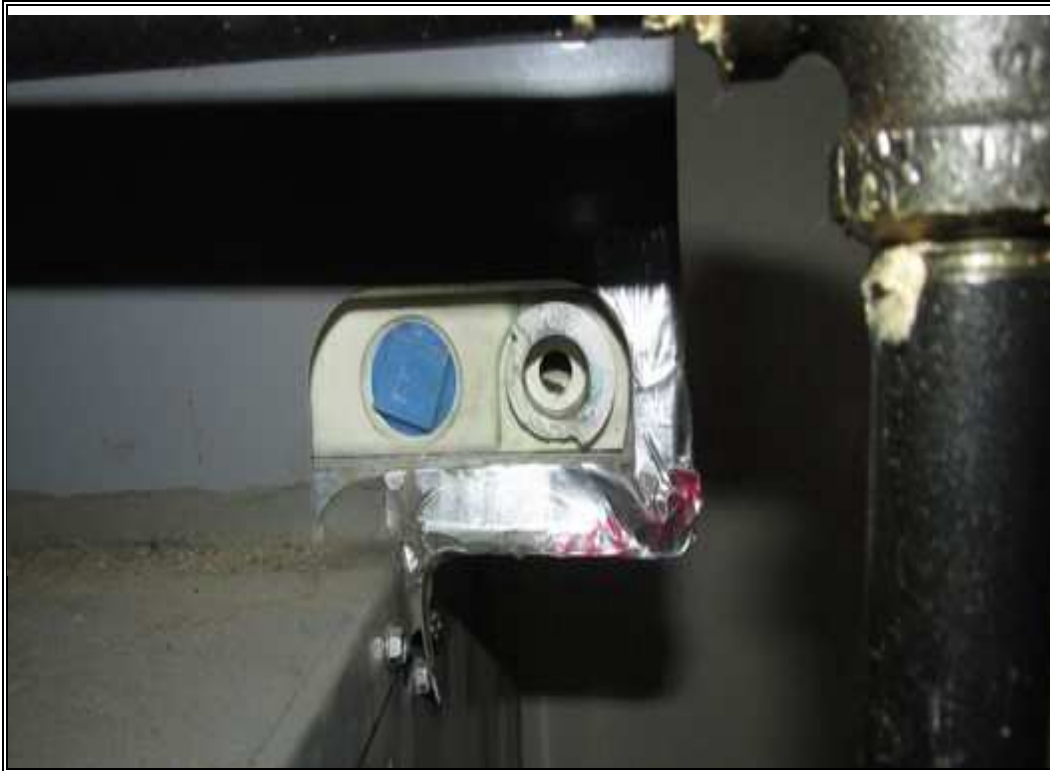
The condensate drain line is damaged at the garage air handler.

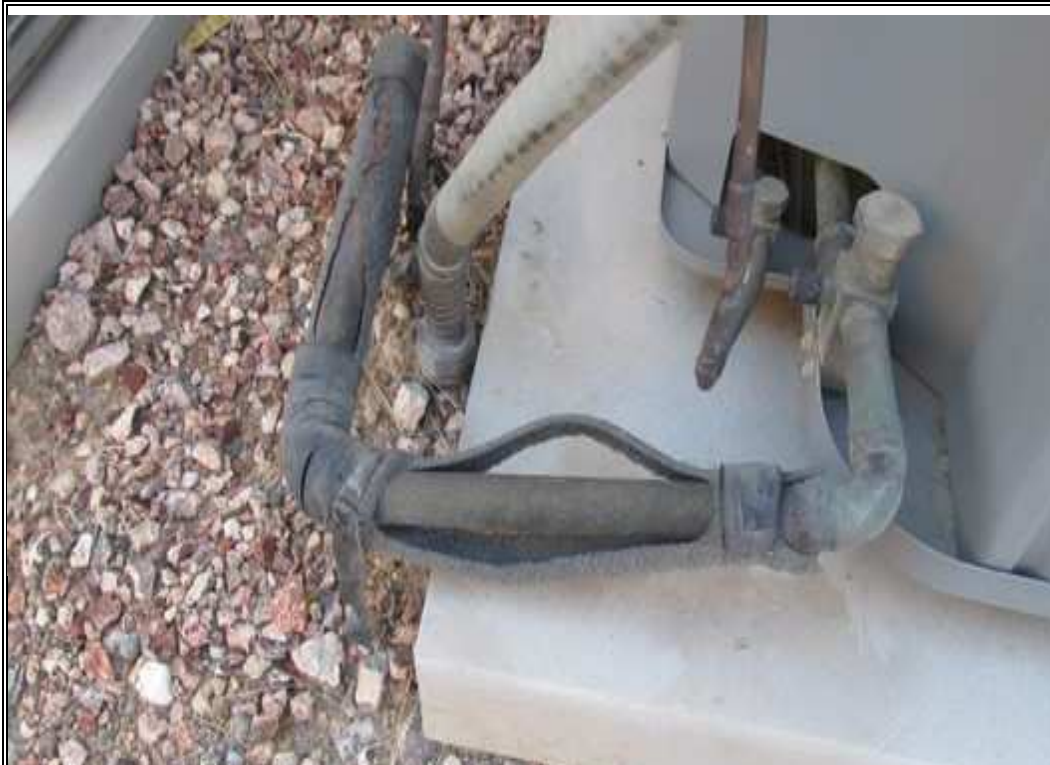
**Photo Number**  
**5**

The insulation is worn on the AC pipes.

- Replace worn/damaged air conditioning refrigerant line insulation.
- Seal any air leaks in attic ductwork.
- Insulate water heater and exposed hot water pipes.
- Set hot water temperature to 120°F or less.

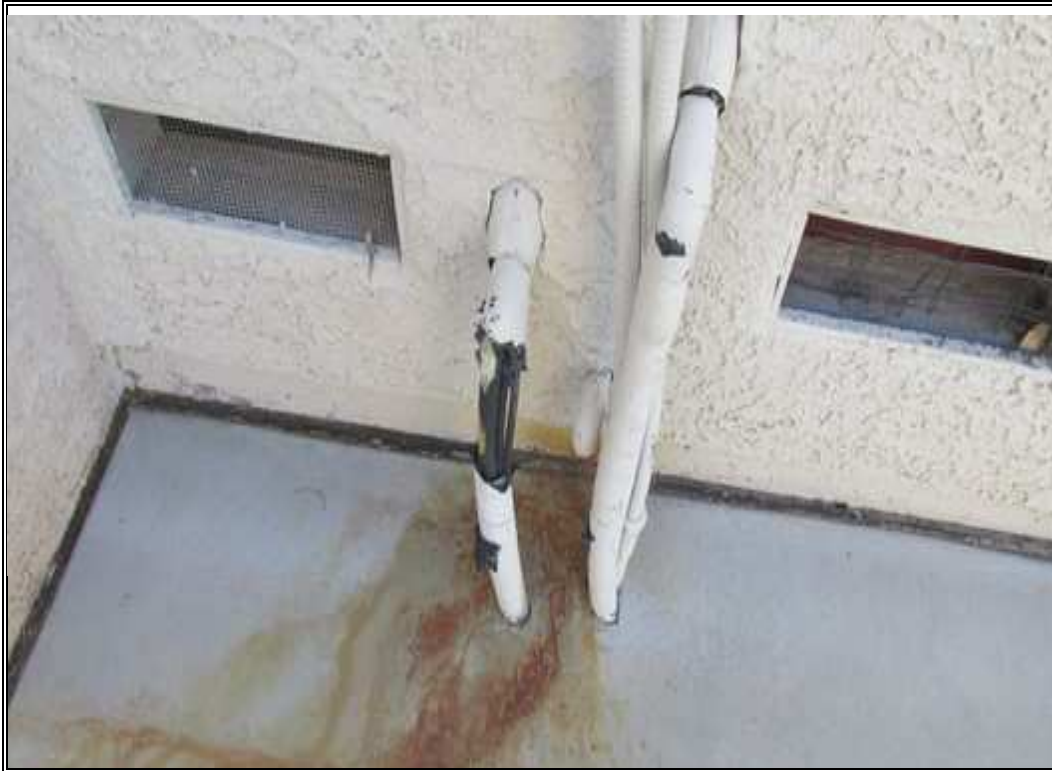
The insulation is worn on the AC pipes.

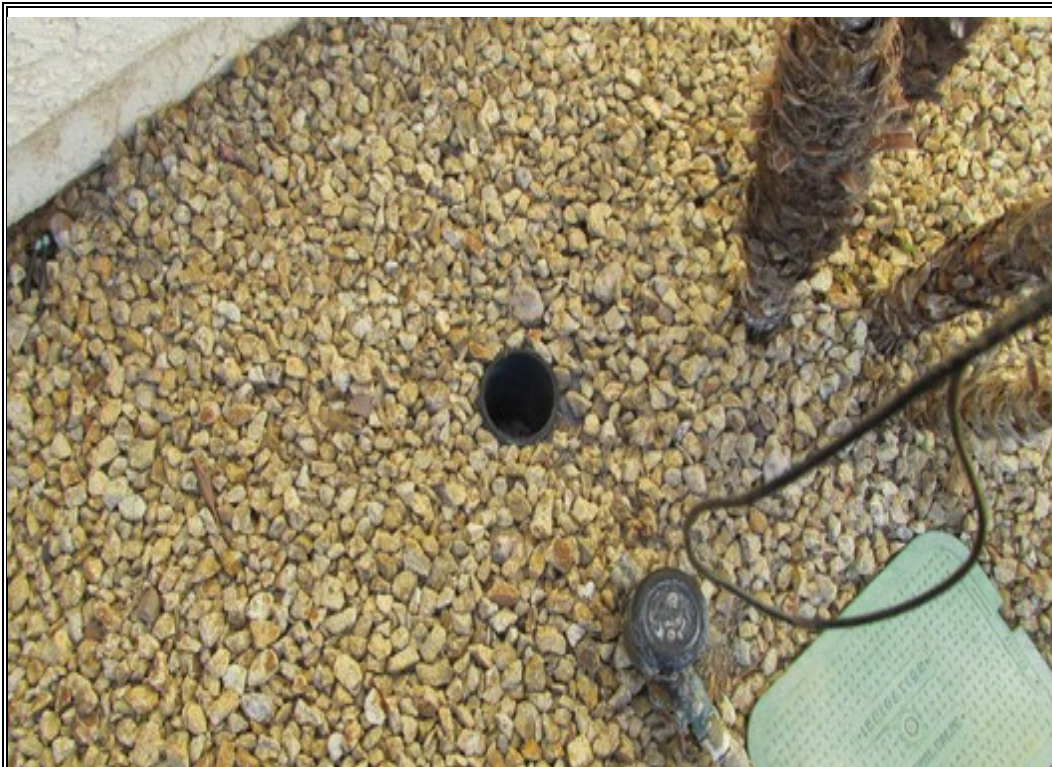
**Photo Number**  
**7**

The clean-out at the front of the house should have a permanent screw top cap.

- The drain cleanout at the front yard is full of debris. It should be cleaned out and a permanent screw-type cap installed.
- The gas line at the back of the house should be capped if not used.
- There is a loop or trap in the water heater relief valve discharge piping. This can prevent proper discharge and result in an unsafe condition. The piping should be rearranged or adjusted to drain continuously downward from the water heater to the discharge point.

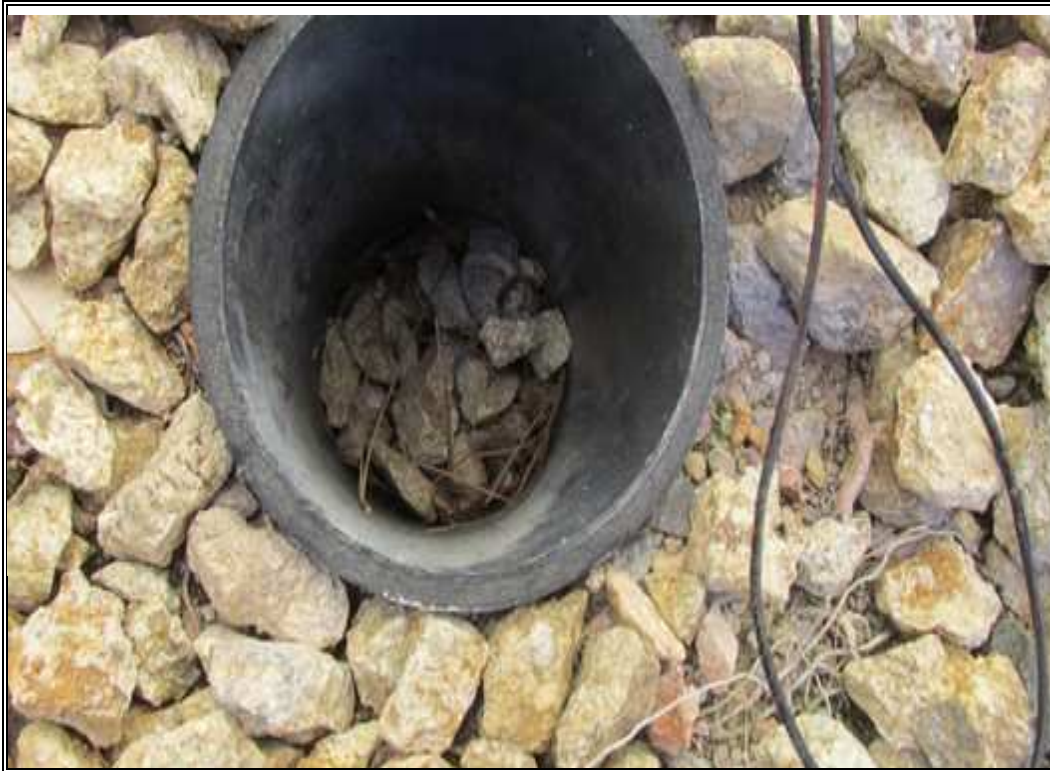
The debris should be removed from the drain clean-out.

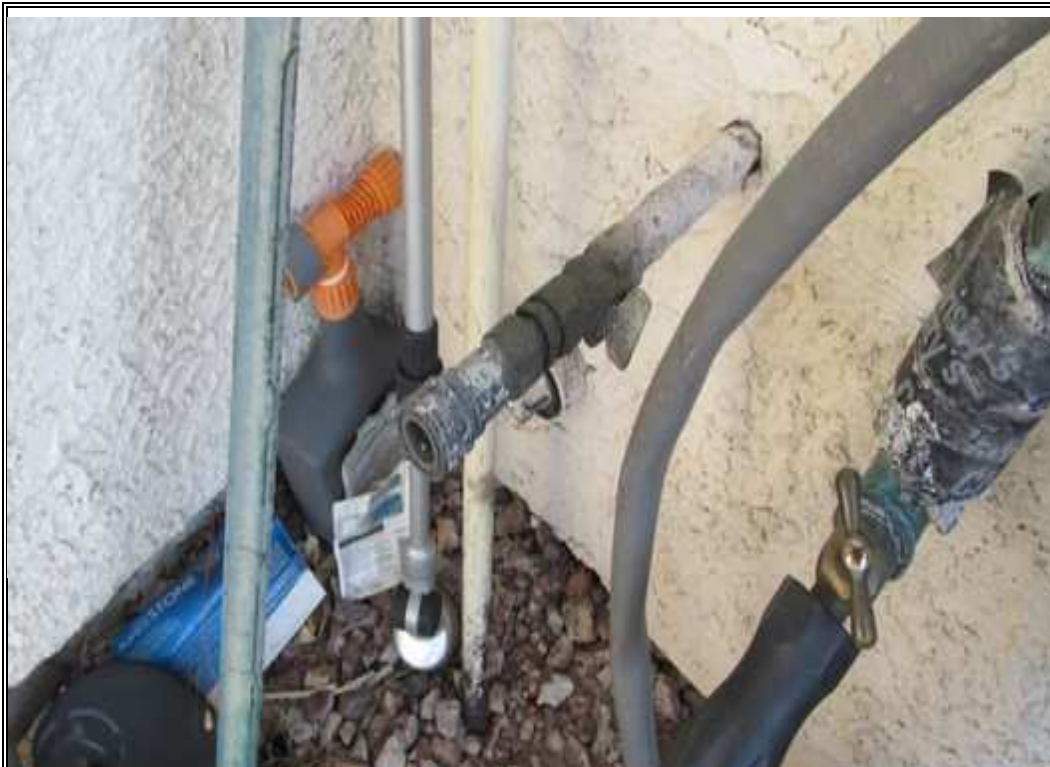
**Photo Number**

The gas line at the back of the house should be capped if not in use.

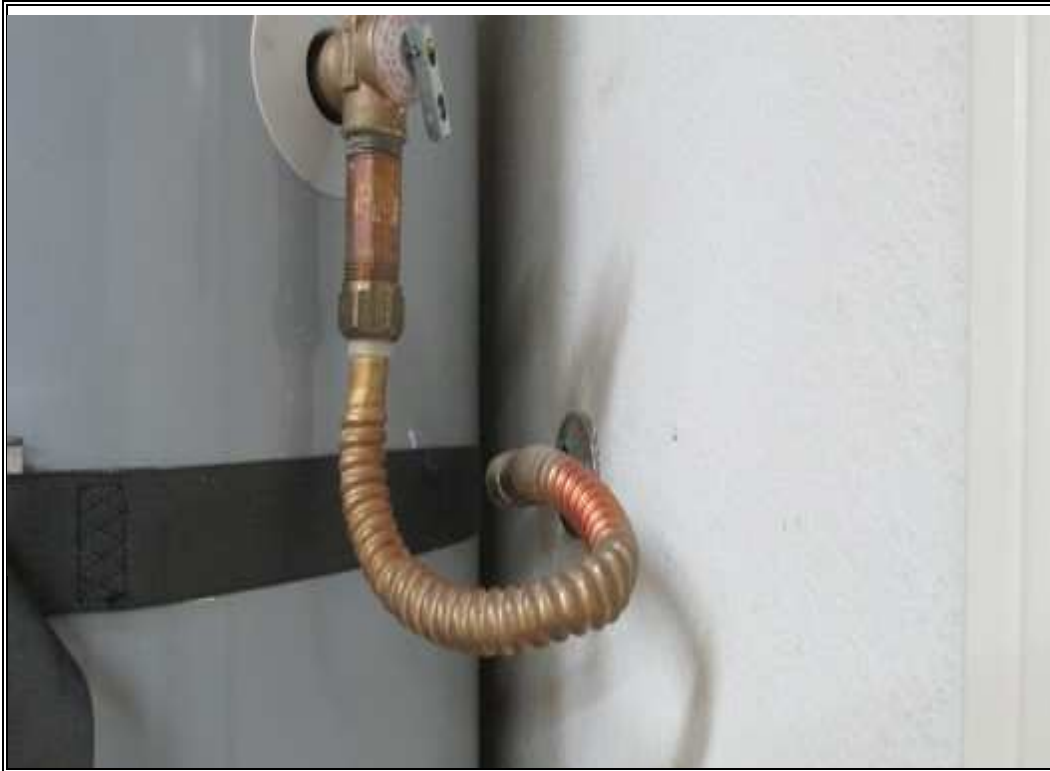
The drain line for the water heater safety valve is trapped. It should flow downward continuously.

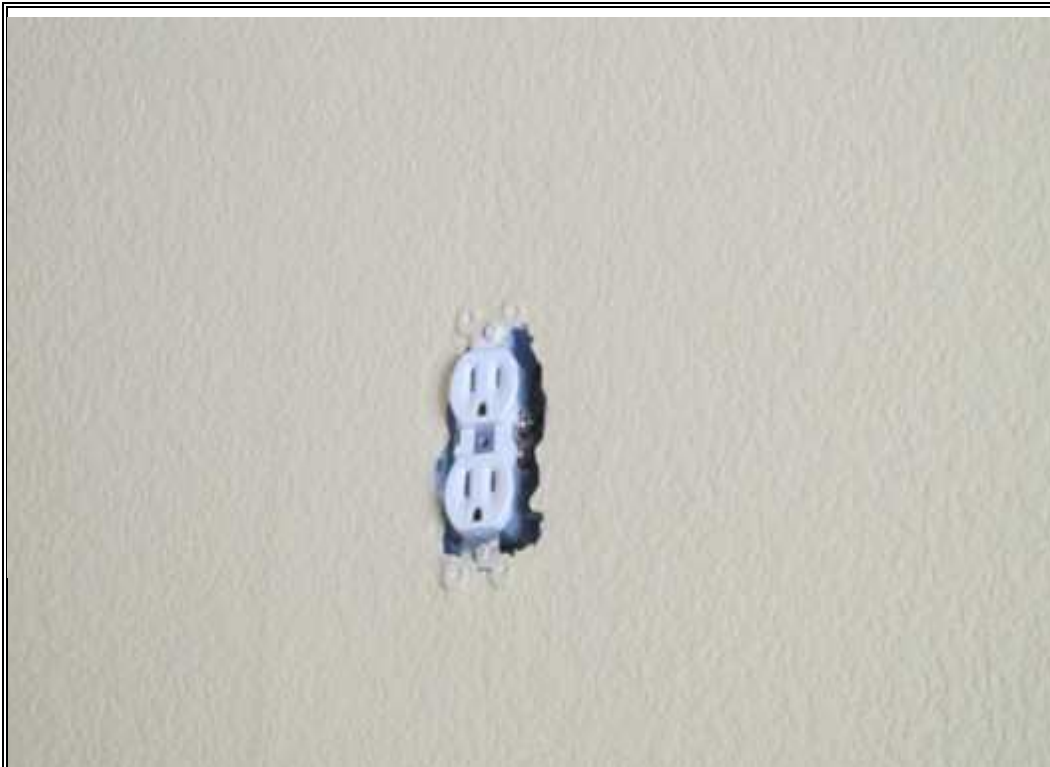
**Photo Number**  
**11**

There is a missing outlet cover in the sunroom.

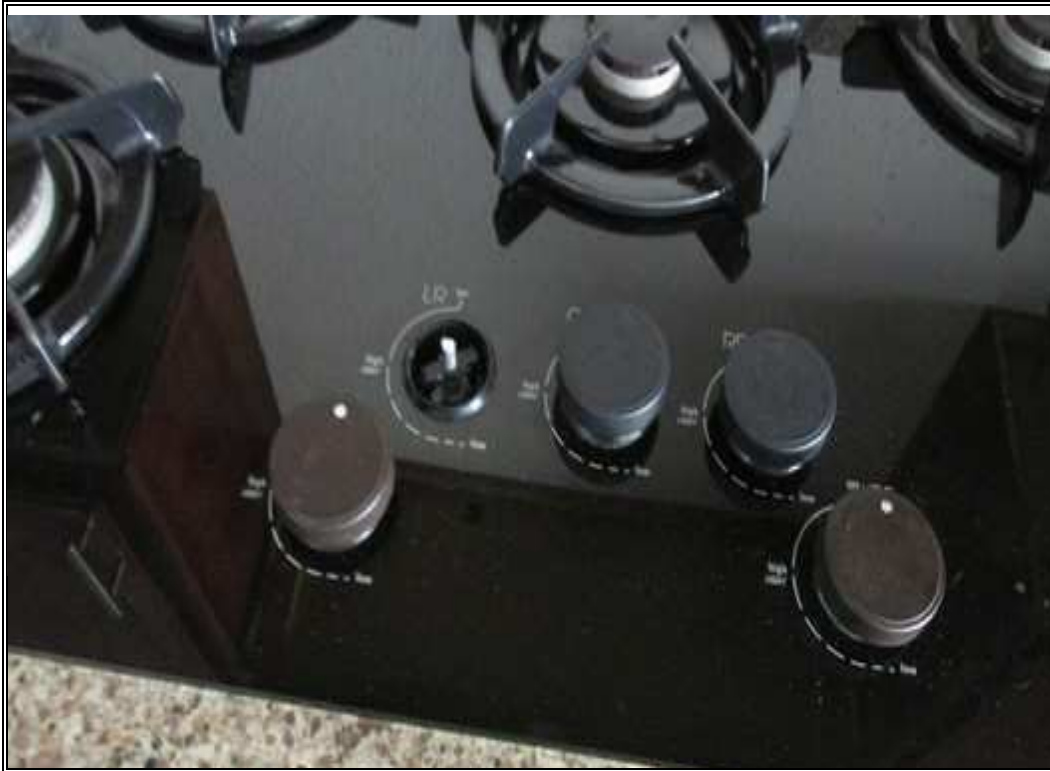
A control knob is missing from the stove top.

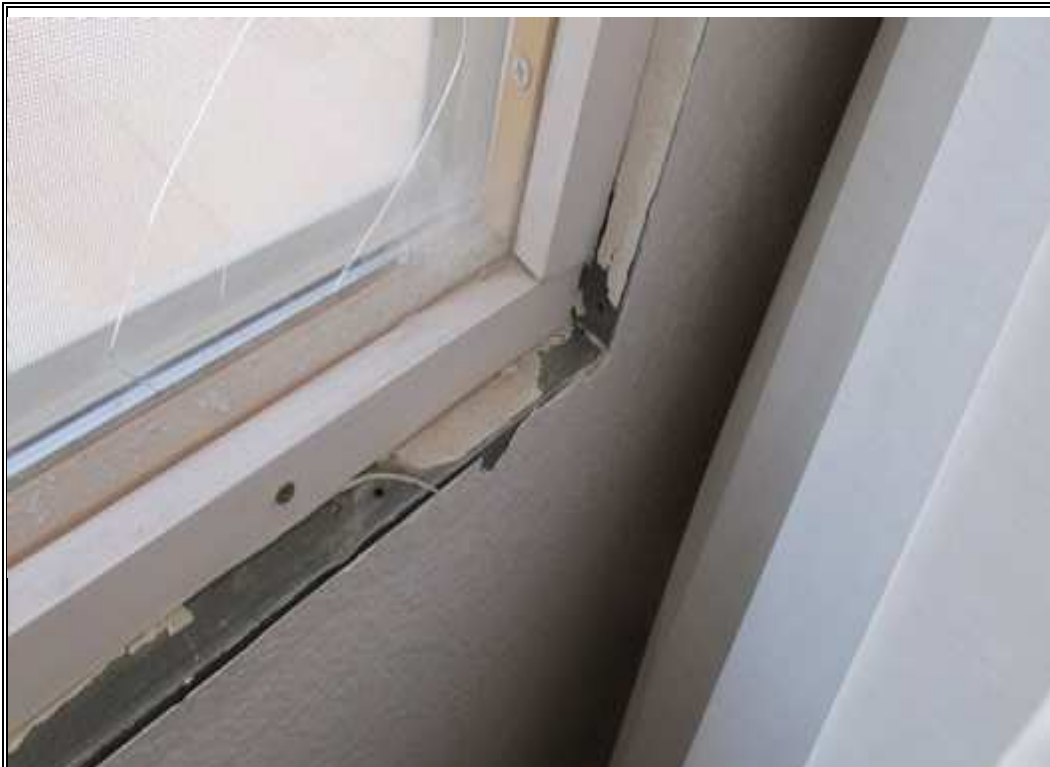
**Photo Number**  
**13**

The dry wall is damaged at the master bedroom window.

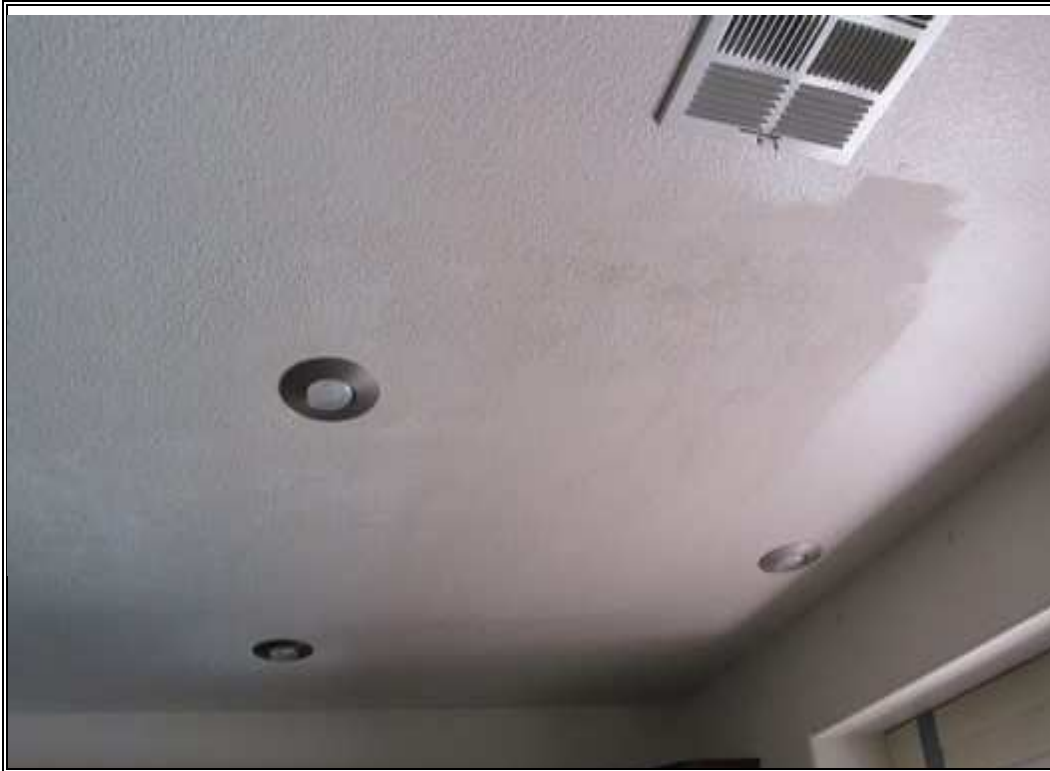
- There is no secondary latch on the patio sliding glass door.
- There is a missing stovetop control knob.
- The drywall is damaged at the master bedroom window.
- There was evidence of previous leaking at the kitchen ceiling. It appears that this was the result of plumbing leaks. We recommend repairs.

There is water damage at the kitchen ceiling.

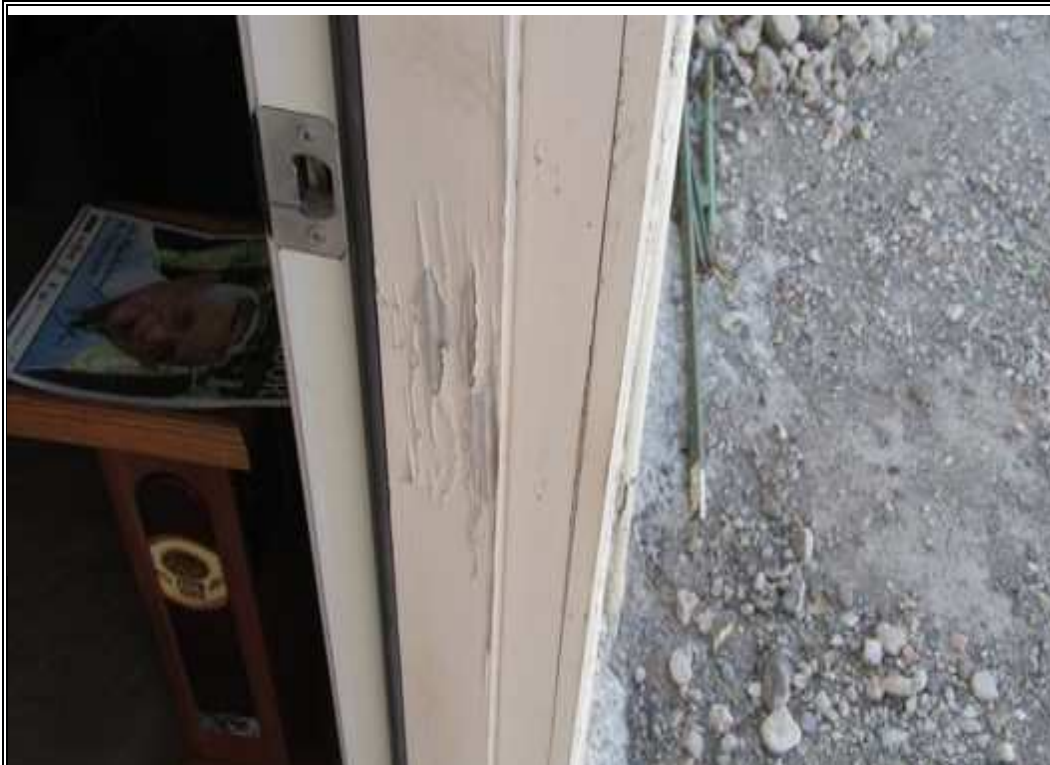
**Photo Number**  
**15**

The exterior trim paint is worn.

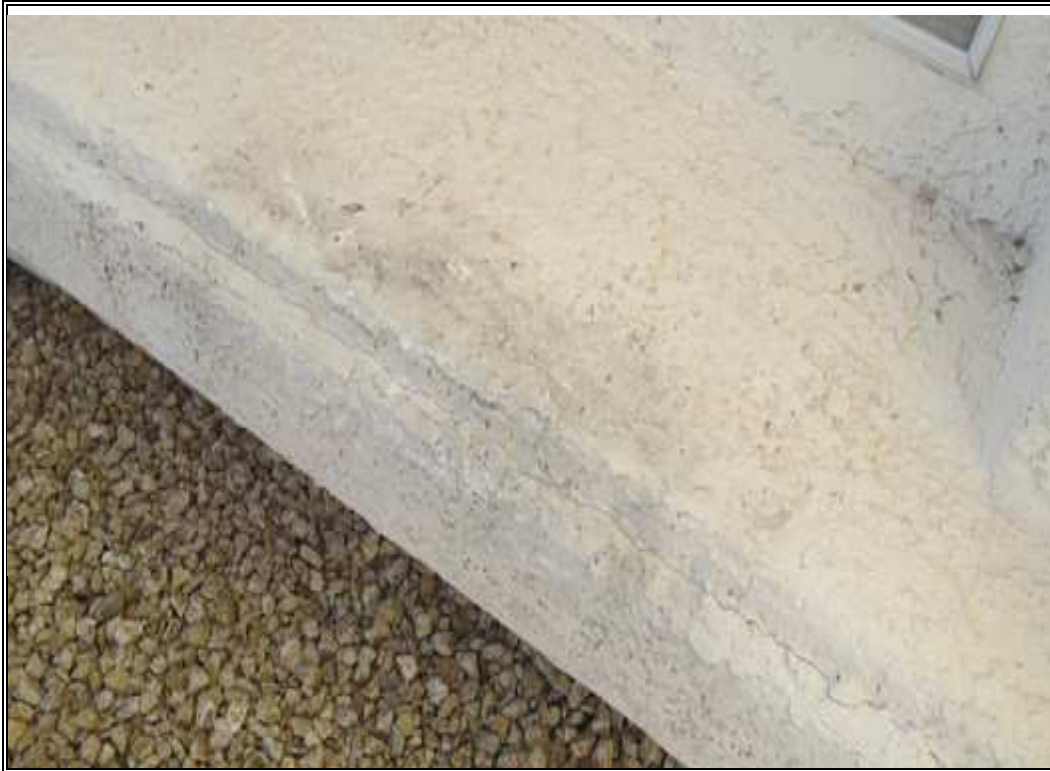
There are cracks in the stucco at the pot shelf ledges.

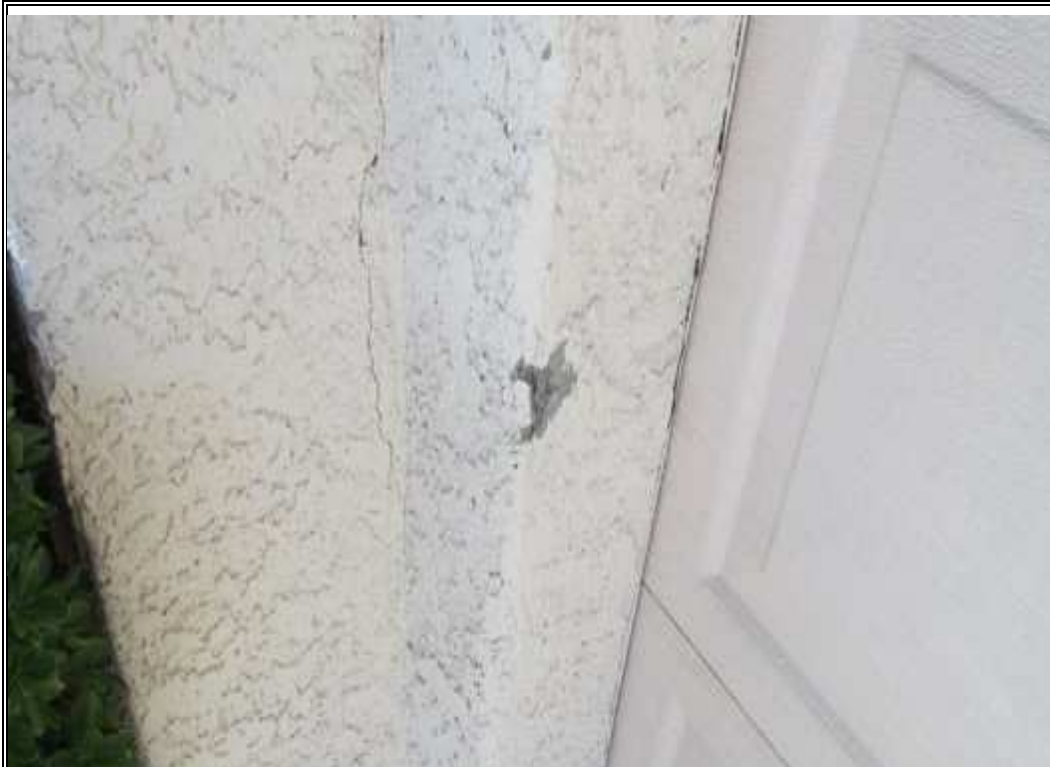
**Photo Number**  
**17**

The stucco is damaged at one garage door.

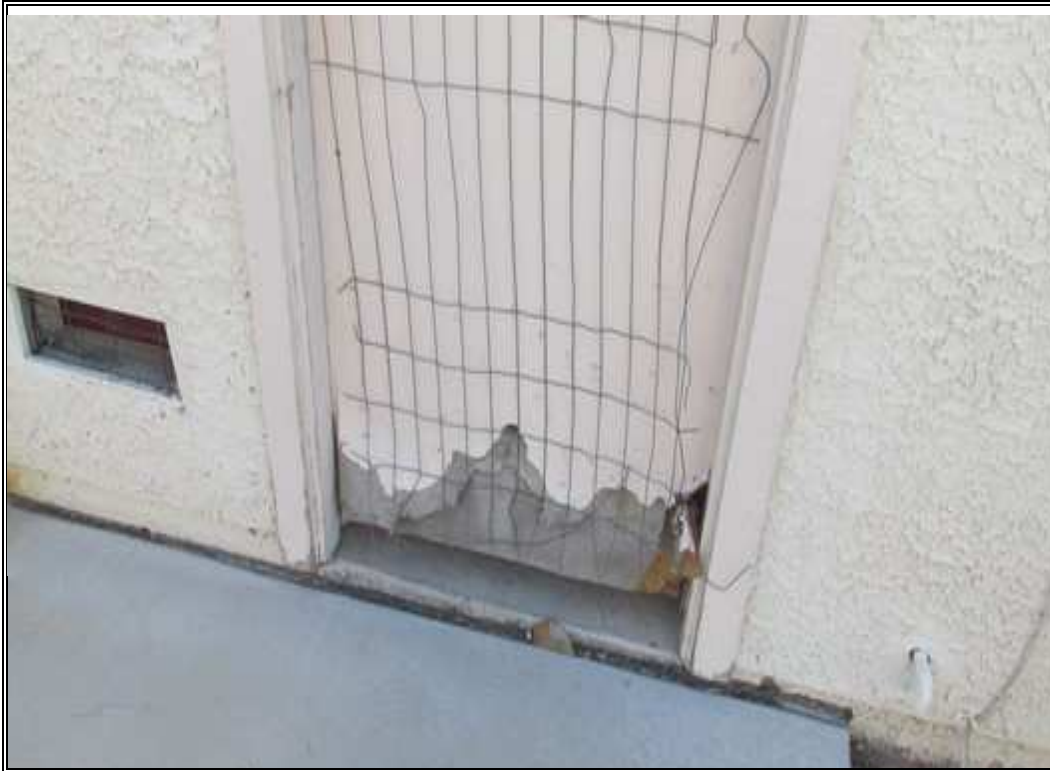
The exterior door at the garage is damaged.

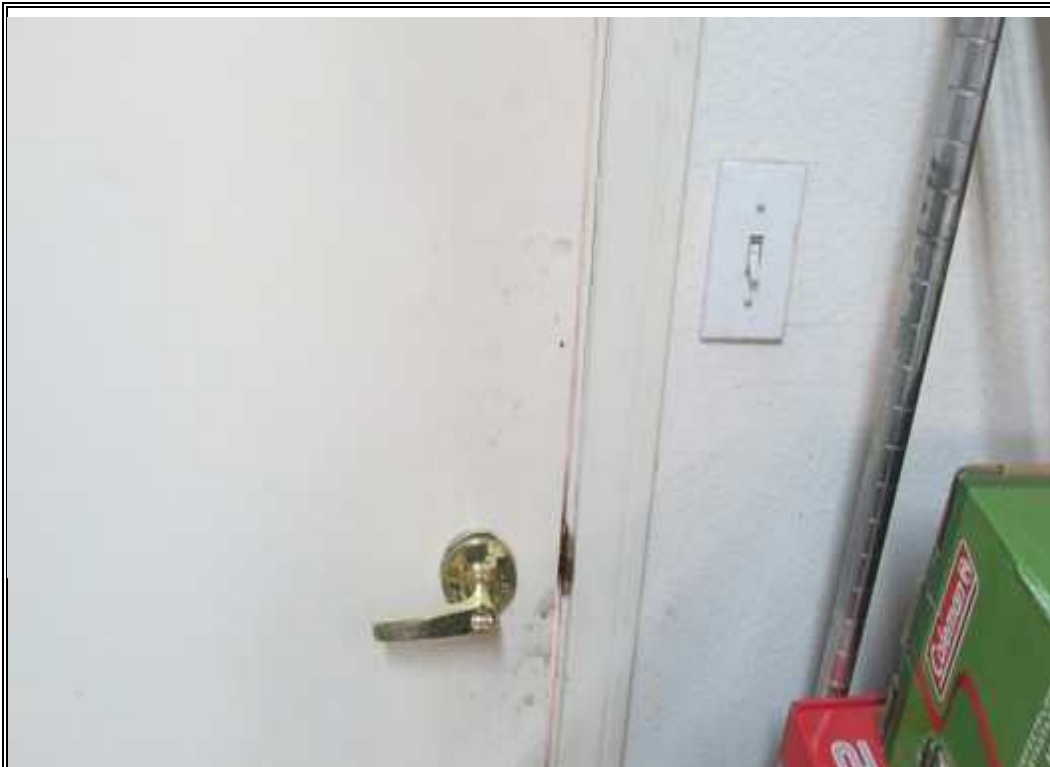
**Photo Number**  
**19**

There is no dead bolt lock at the exterior garage door.

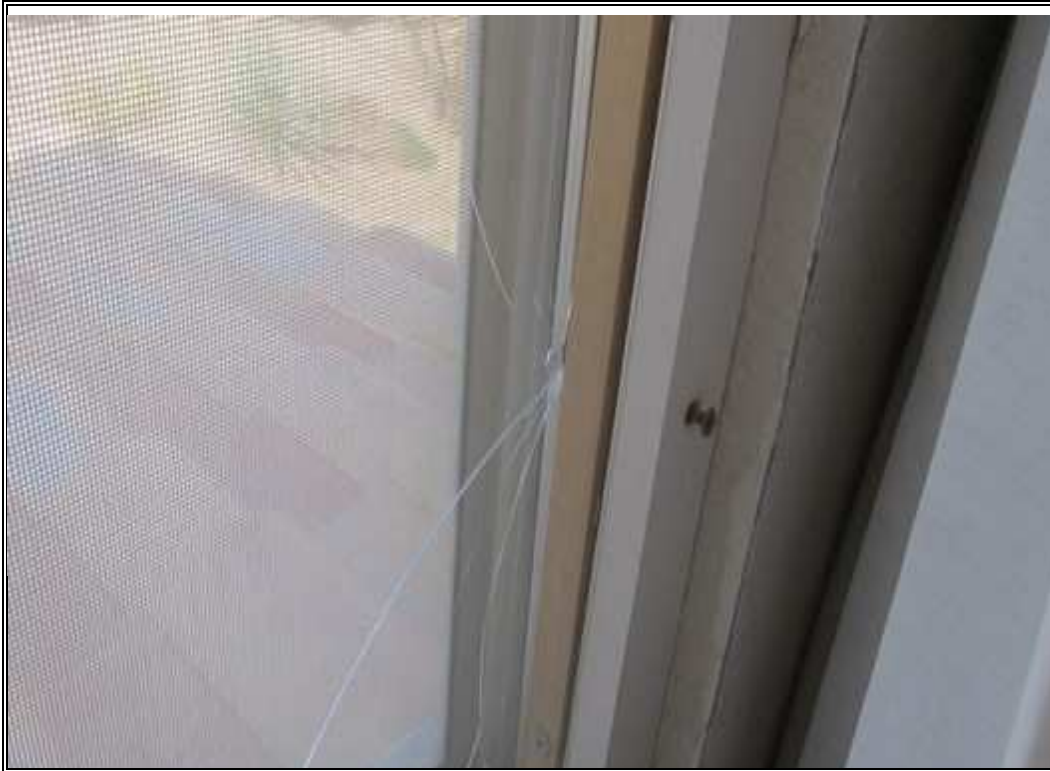
Generally, the windows in this home are standard quality "thermal pane" (double glazed) windows. If kept well maintained and tightly closed in the winter, these windows should serve you well. The seal is broken in one of the window sections in the master bedroom, and it should be repaired to reduce heat loss and to improve comfort.

There is a cracked window in the master bedroom.

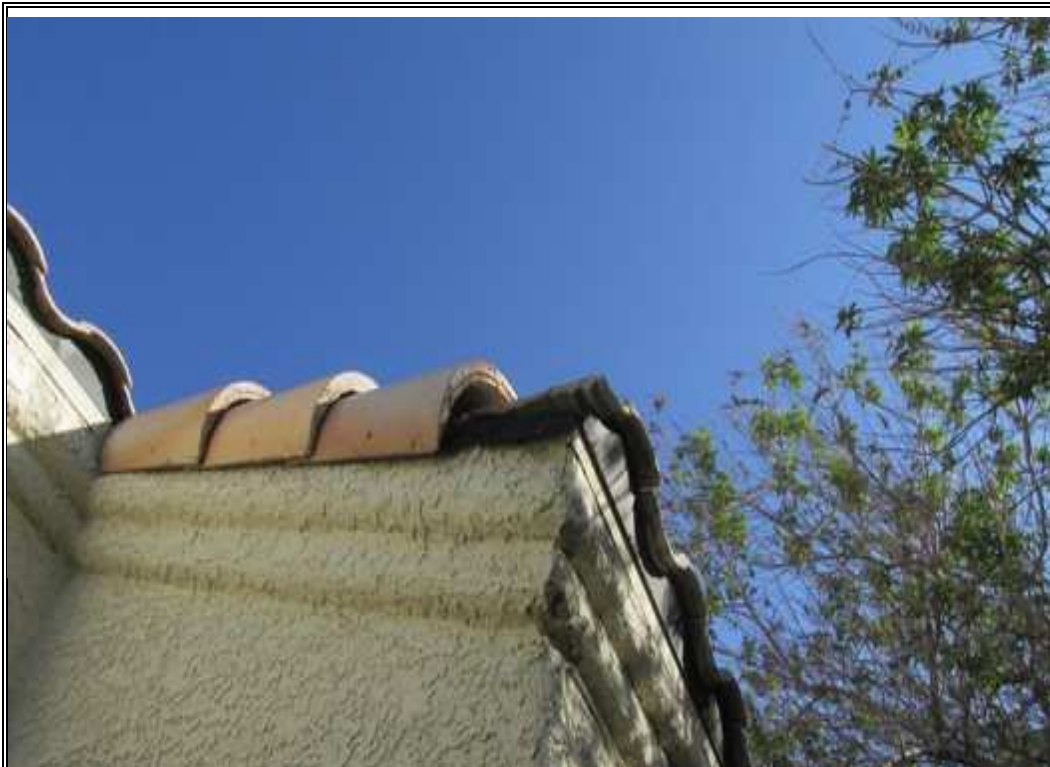
**Photo Number**  
**21**

There is a missing roof edge tile.

- Repair roofing
  - There are a few loose, slipped out of place, or cracked tiles that should be repaired.

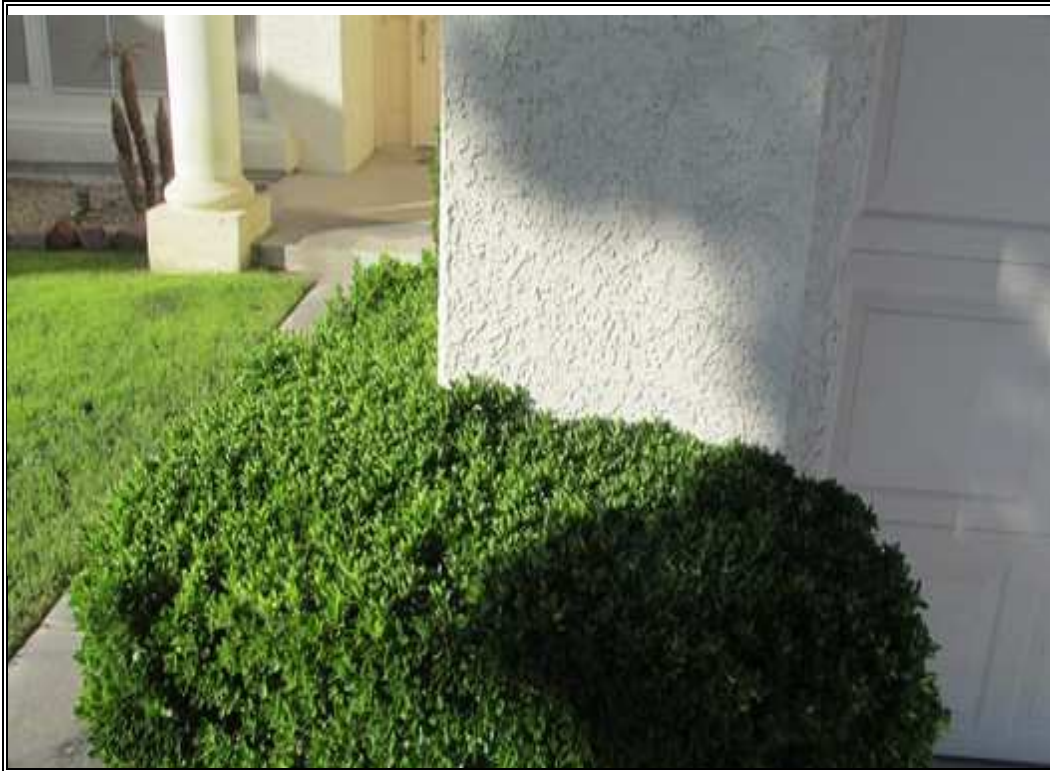
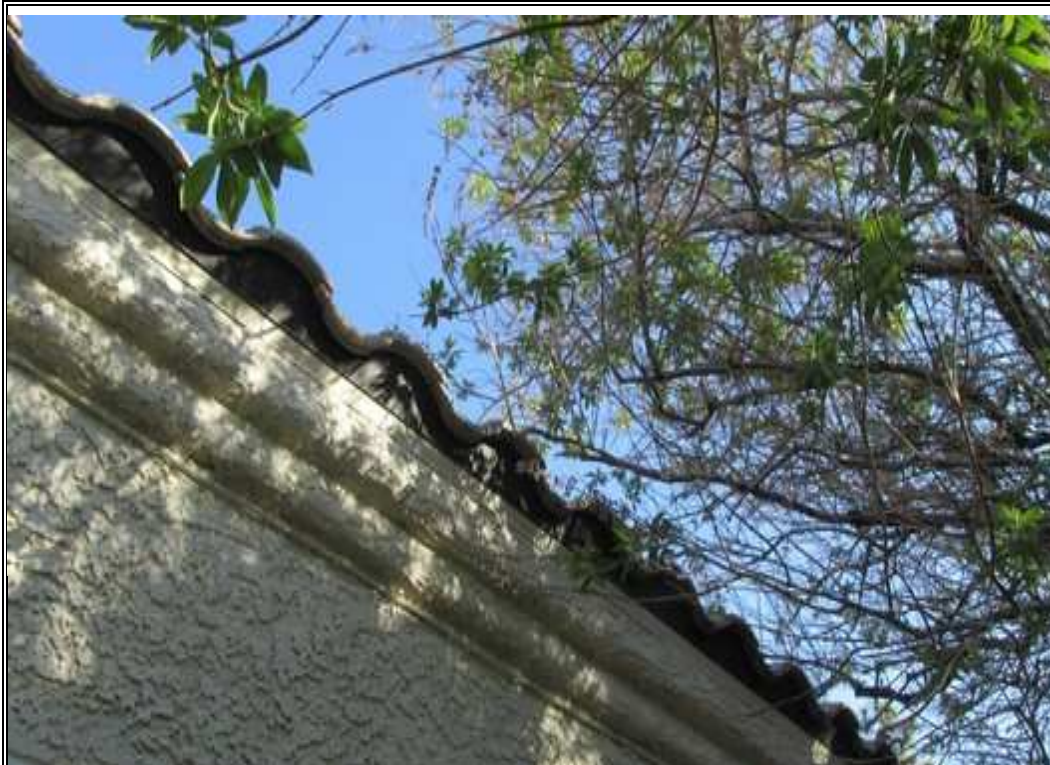
**Photo Number**  
**23**

The shrubs and trees should be trimmed away from the stucco and roof.
